GENESIS

MISHAP INVESTIGATION BOARD REPORT VOLUME I

GENESIS MISHAP REPORT VOLUME I

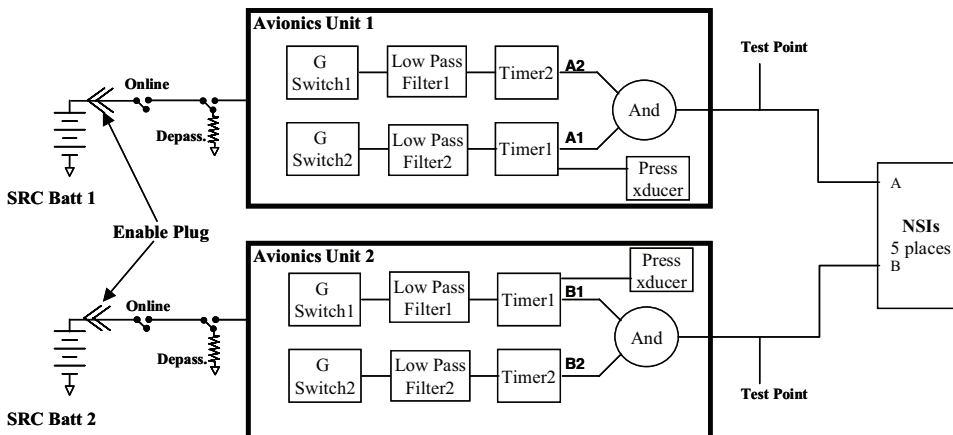
*Figure B.11.
SRC avionics
pyrotechnic firing
system.*

Figure B-11 is a simplified block diagram of the SRC avionics system pyrotechnic firing system. The low-pass filter is designed to prevent inadvertent G-switch circuit atmospheric transients (buffeting) as the increasing deceleration passes through 3 g's . The G-switch sensors are 'ANDed' to preclude a single switch failure from prematurely issuing a deploy signal. The AUs are referred to in development phase documentation as 1 and 2 or A and B alternatively with 1 = A and 2 = B.

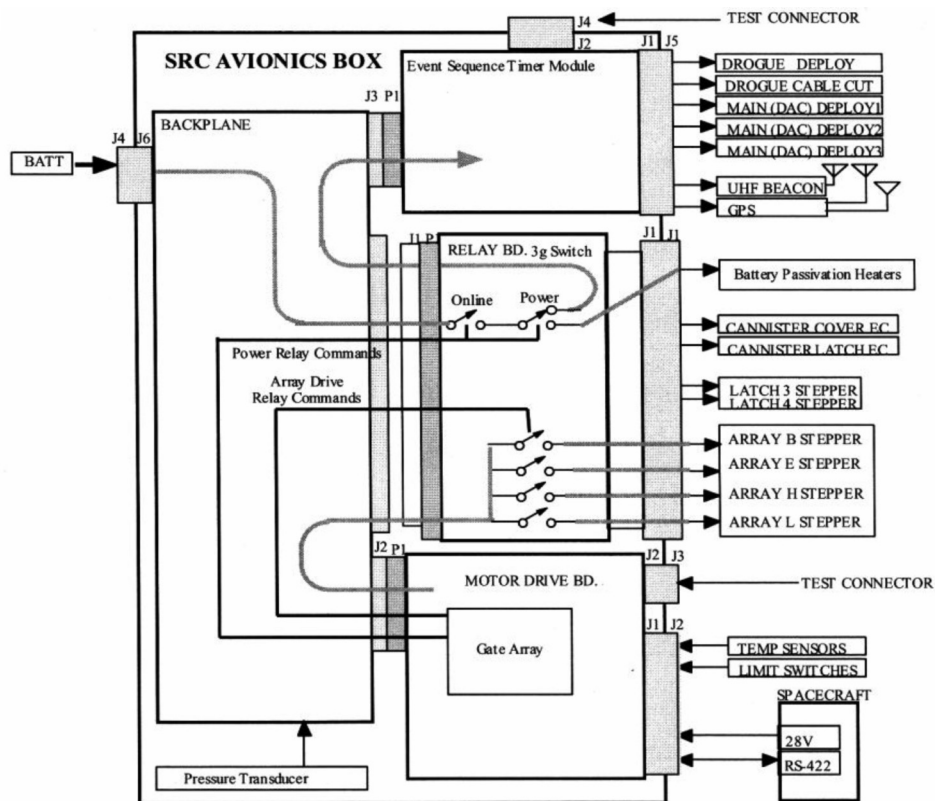
Figure B.12.
SRC avionics unit.

The AU block diagram is shown in Figure B-12. The primary functions performed by the Motor Drive Electronics (MDE) board were completed when the science canister and the SRC were closed on April 1, 2004. During the SRC Release Sequence, the relay card and the FPGA on the MDE board are used only to connect the SRC LiSO_2 batteries to the depassivation resistors attached to the interior of the heatshield first and then to the Event Sequence Timer (EST) board to power it through entry and post entry operation of the GPS transceiver and the UHF beacon. The G-switch sensors were mounted on this relay card for entry, although voltage was applied from the EST card.

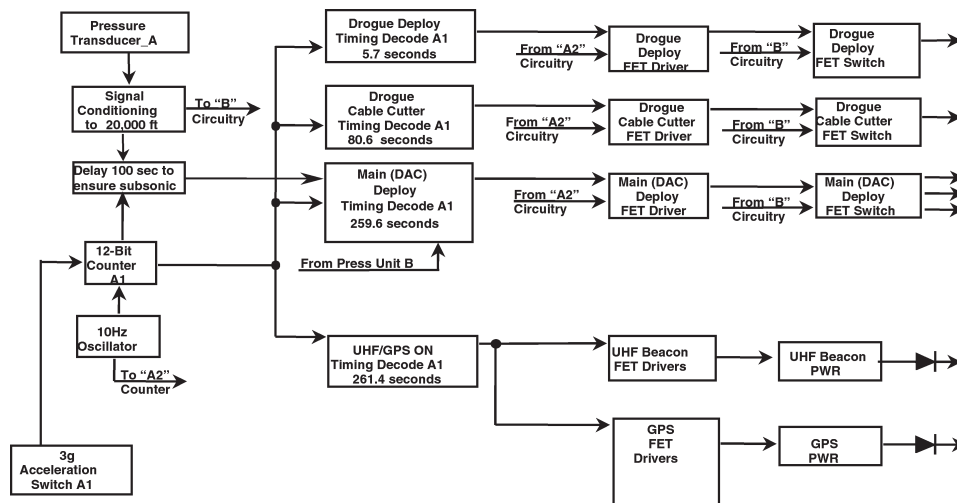
Figure B-13.
Event sequence timer.

The EST block diagram is shown in Figure B-13. The G-switch sensor initiates all the R-C timer circuits set to fit the entry profile (see Table B-3 event times). The drogue parachute stabilizes the capsule during the passage through transonic velocities, nominally being deployed at Mach 1.8. The drogue cable cut could be done anytime between drogue deploy and DACS firing. The DACS firing is timed to correspond to about 22,000 ft (72 km) above MSL. The pressure transducer is a back-up to timed parafoil deployment but is switched on by a timer sequence initiated by the G-switch sen

sor. It is intended for back-up initiation for parafoil deployment in case the estimated timing of the descent sequence was incorrect. It is not intended as a back-up to the G-switch sensor. The redundant AU circuits are cross strapped and the boxes are cross strapped, as shown in Figure B-13. The UHF beacon and the GPS transceiver provide location information in case of a failed Mid-Air Retrieval.

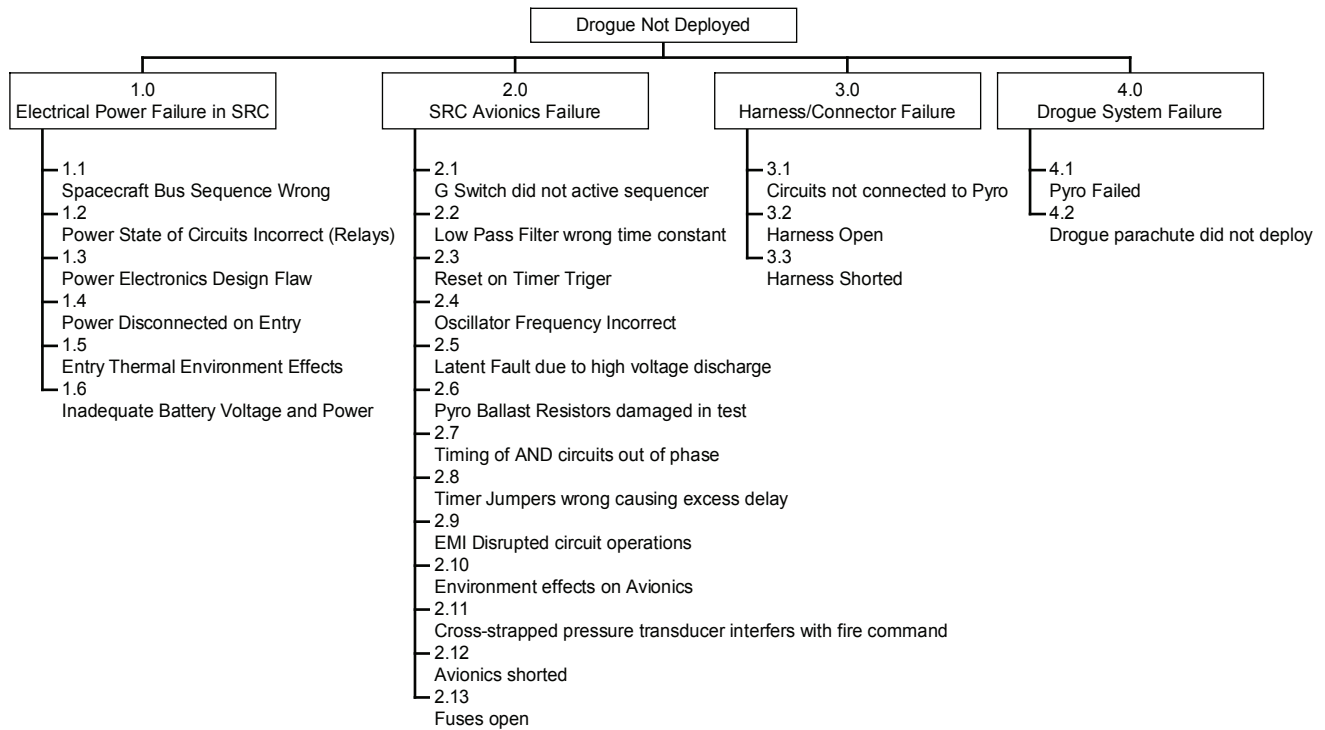
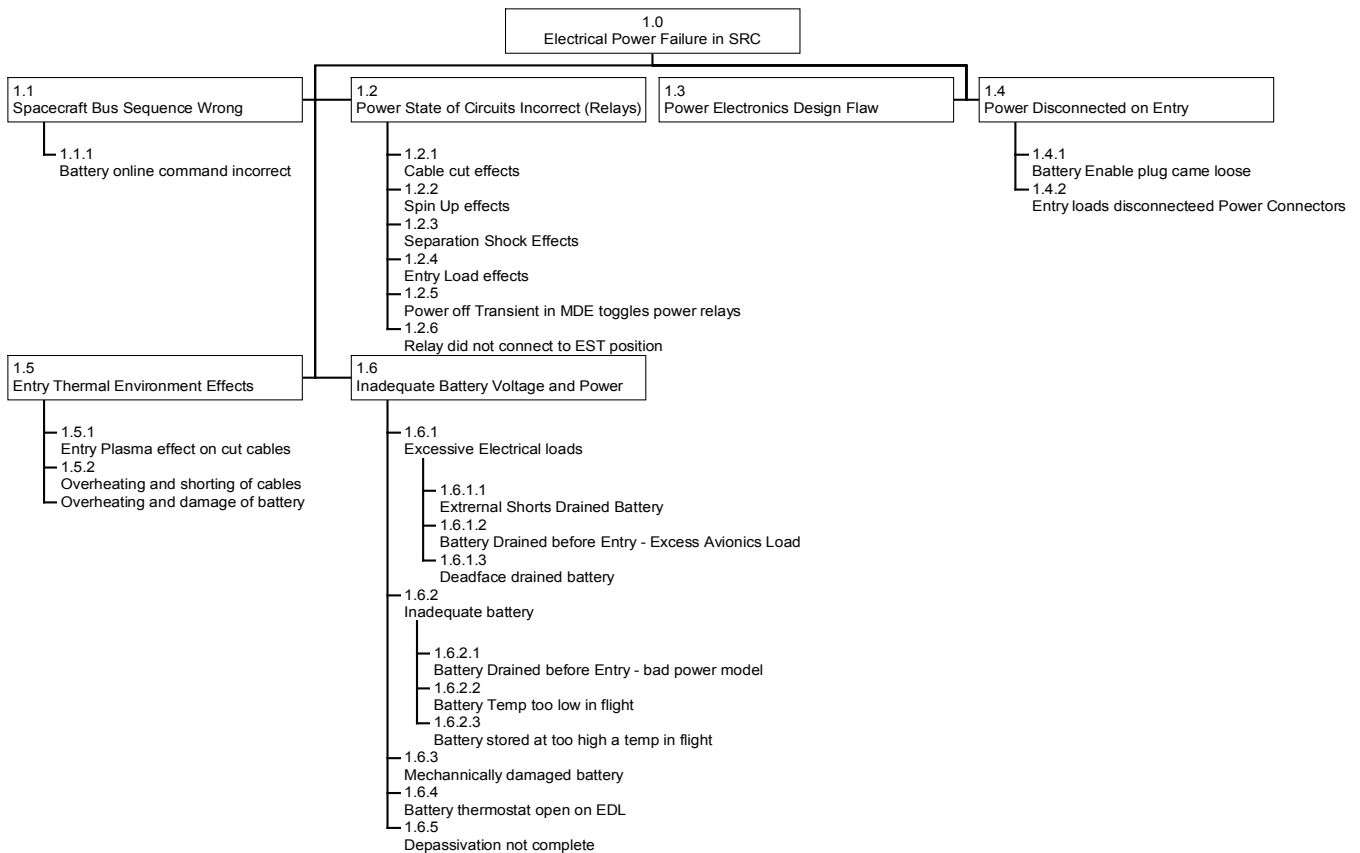
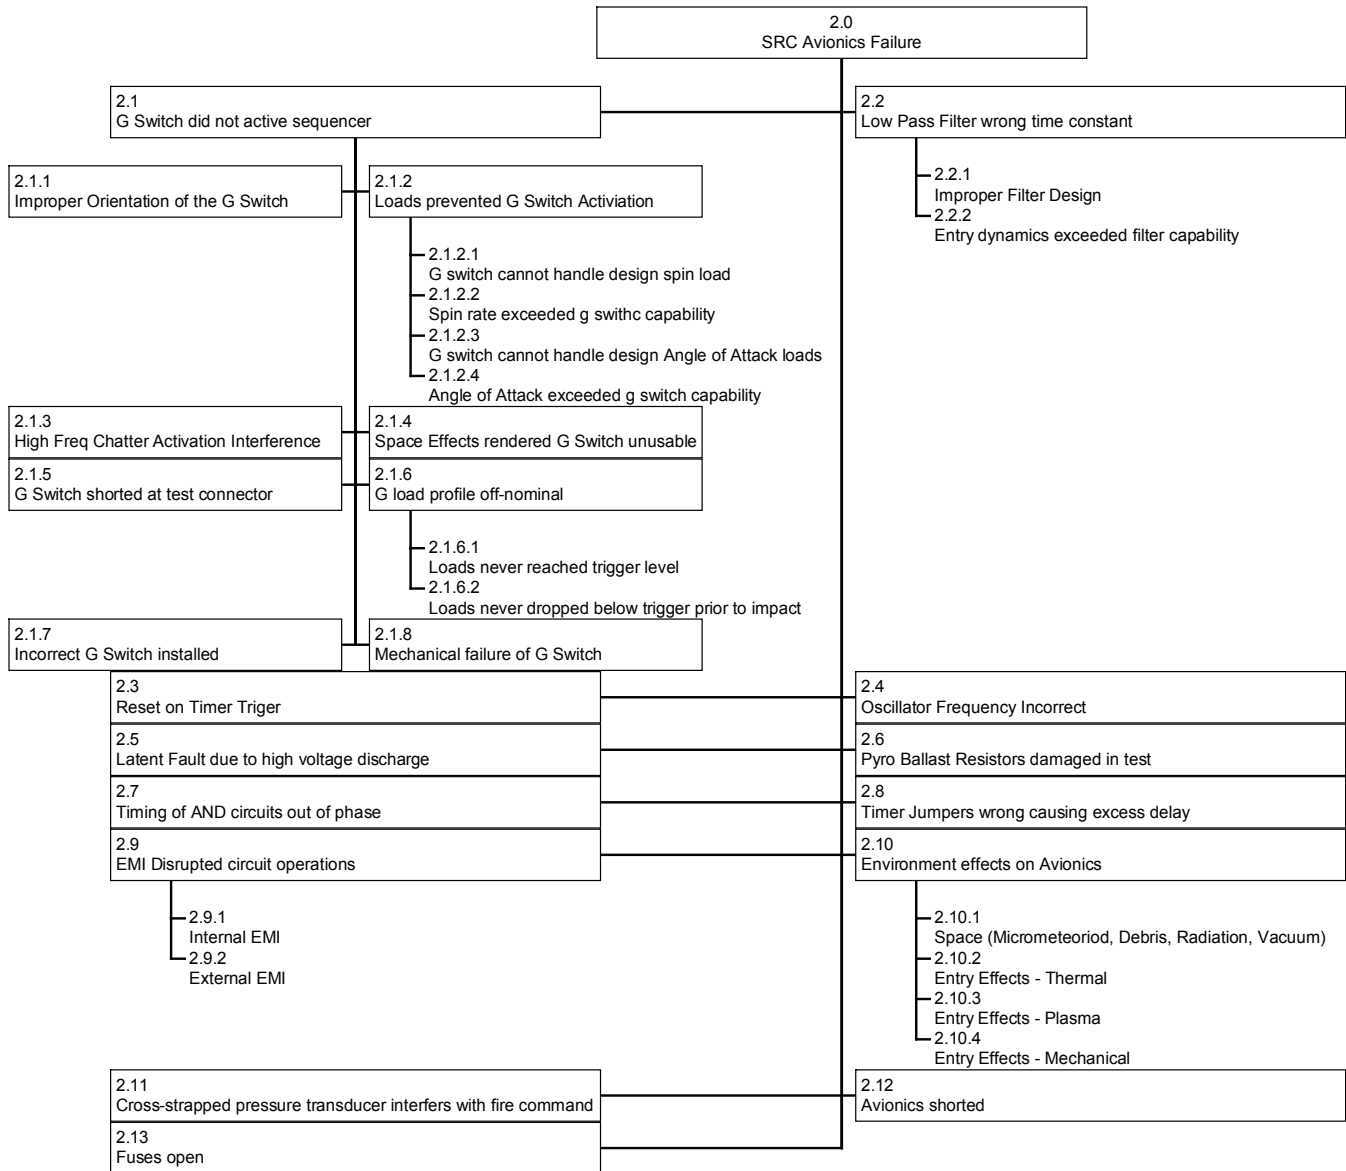
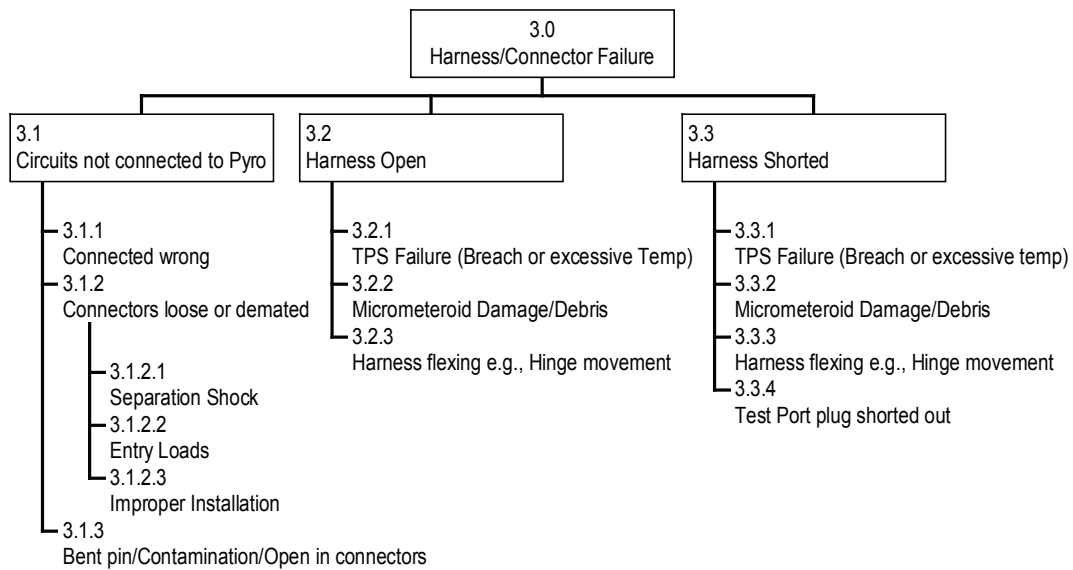
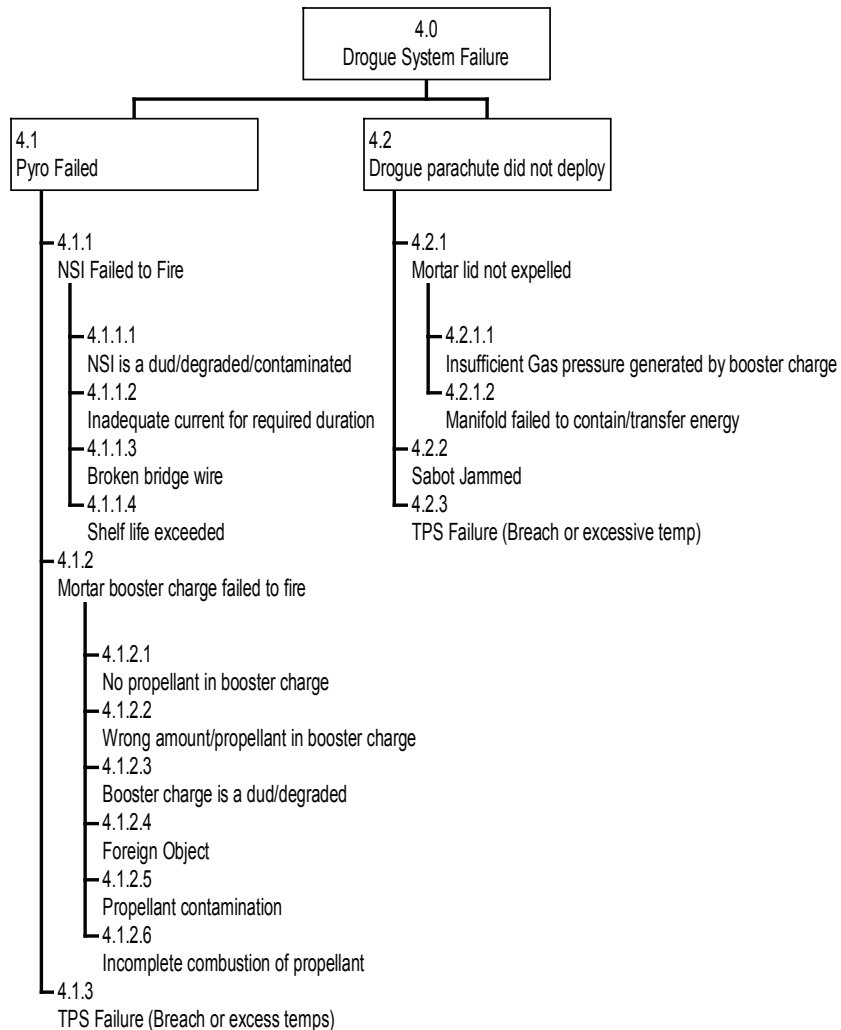
FAULT TREE DIAGRAM

Figure E-2 contains the Event and Causal Factor Tree for the Genesis mishap, a visual representation of the causes that led to the mishap. The MIB used a fault tree(see Appendix C-2.A.) to identify the possible causes leading to the mishap and the Event and Causal Factor Tree was then used to further decompose those events by asking why each event occurred. The MIB continued this “why” process until they identified the root causes and causal factors.

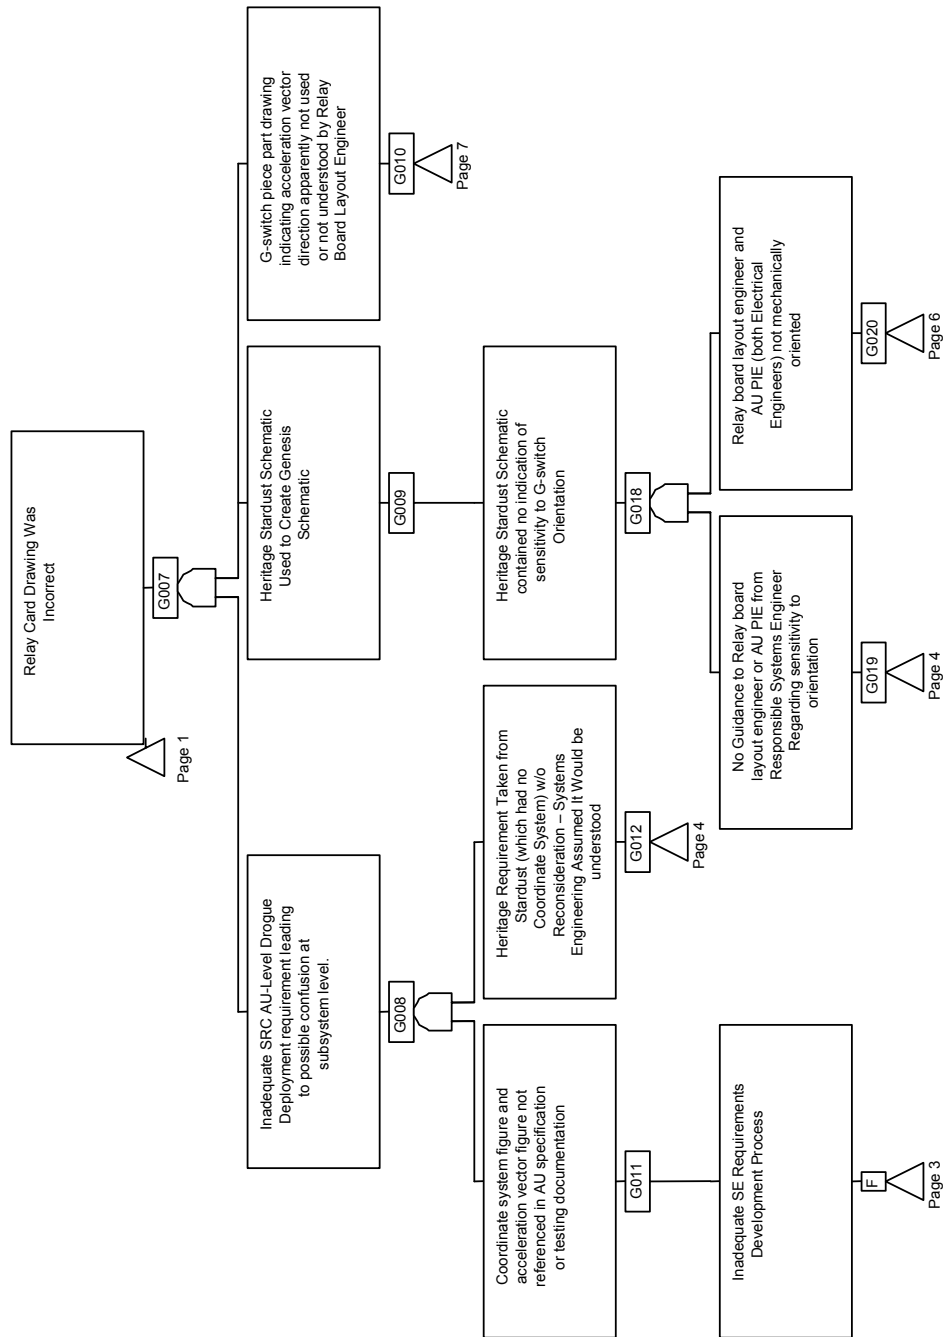
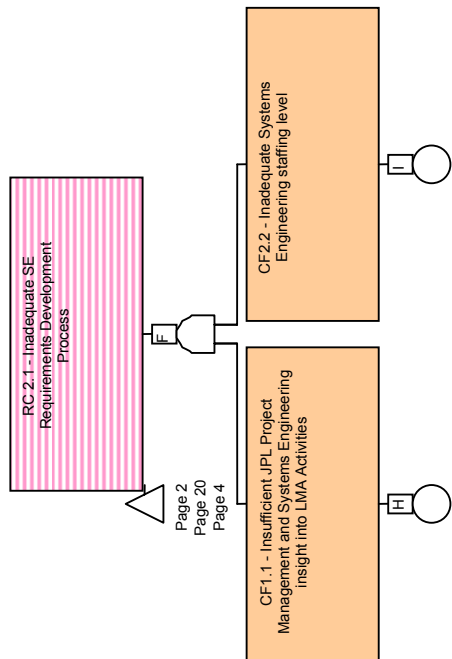
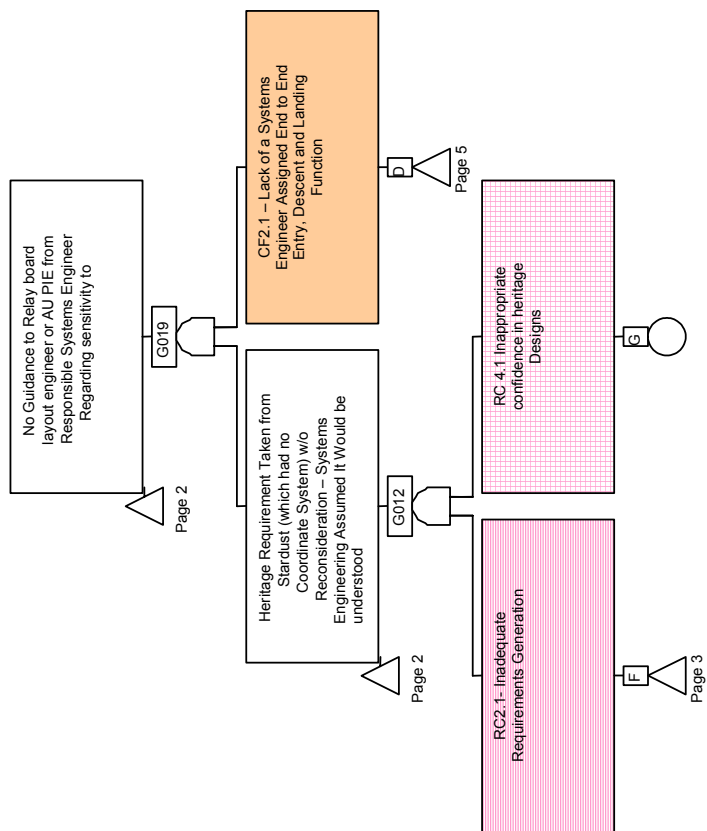
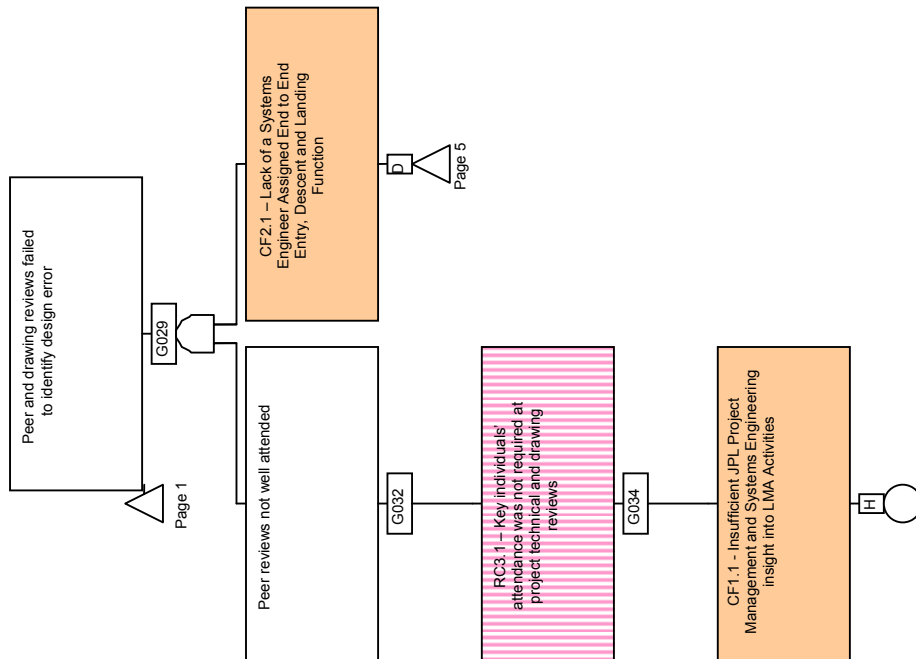
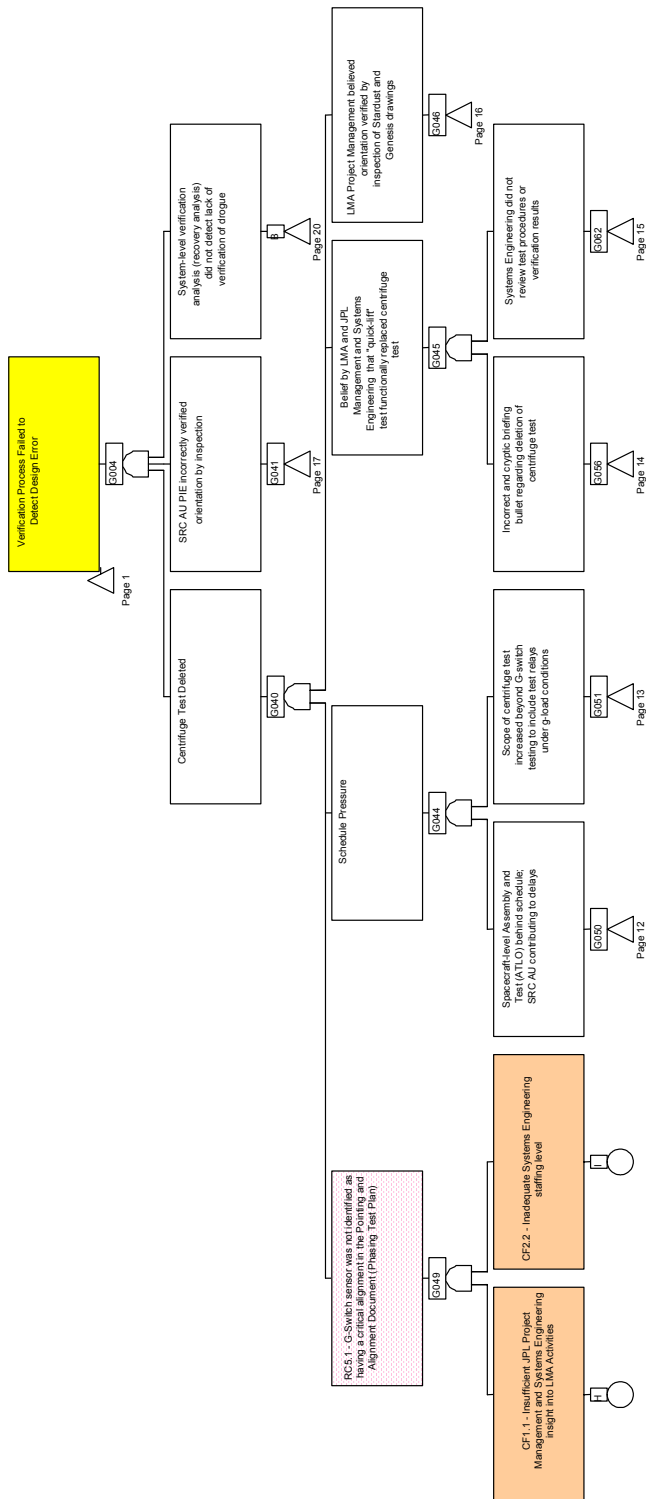
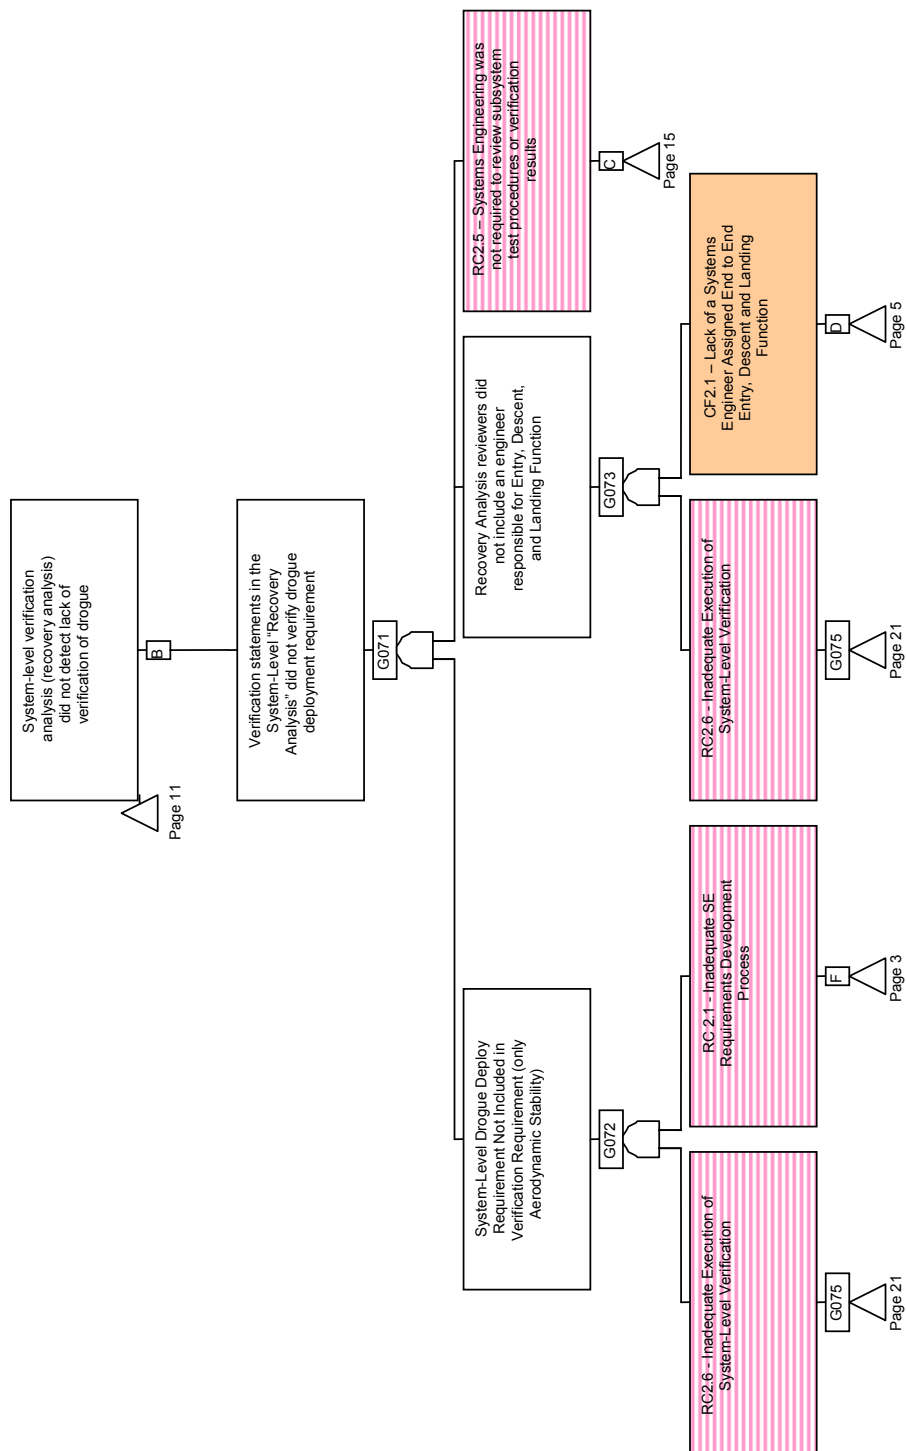
Figure E-2. Event and Causal Factor Tree.

The Genesis Project had a number of interrelated issues that led to the inversion of the G-switch sensors -- the proximate cause that resulted in the drogue parachute deployment mishap. After extensive review of the data and numerous interviews, the MIB determined that deficiencies in the following four pre-launch, top-level processes resulted in the incident, each involving multiple root causes and contributing factors:

1. the design process inverted the G-switch sensor design;
2. the design review process did not detect the design error;
3. the verification process did not detect the design error; and
4. the Red Team review process did not uncover the failure in the verification process.
